Seasonal Progress Report #2
SR431 Treatment Vault Effectiveness Monitoring

Submitted by: Tahoe Resource Conservation District

Submitted to: Nevada Department of Transportation

Period: Spring Season, March 1, 2016 – May 31, 2016

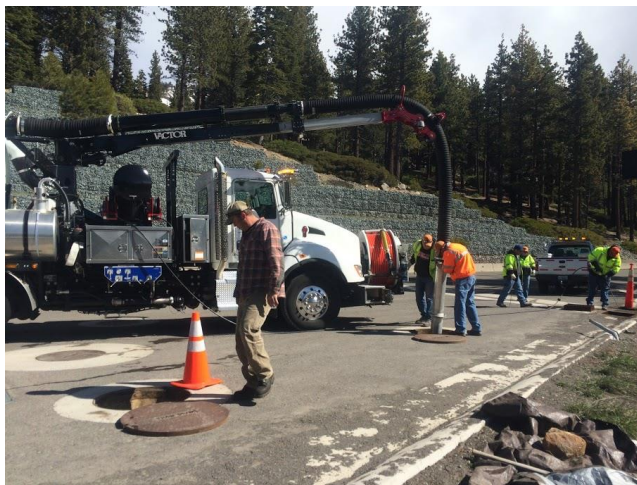
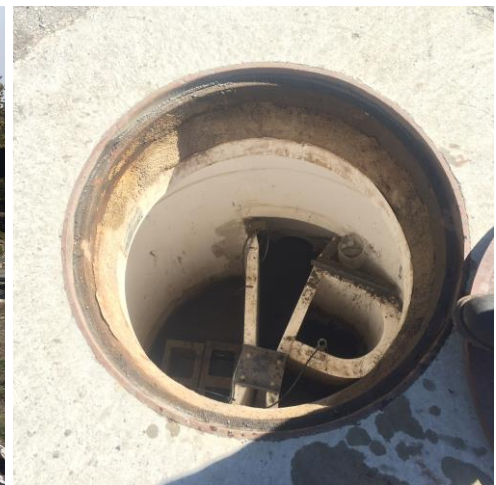
All four stormwater monitoring stations have been dependably collecting continuous flow and turbidity data since the Tahoe RCD took over the project on May 1, 2015 and through the rain event that began March 4, 2016. After this event, it was discovered that accumulated sediment was prohibiting monitoring equipment from collecting reliable continuous turbidity data and samples. Turbidity readings in February, March, and April may be compromised. NDOT was notified that the vaults needed to be cleaned out via email on March 6, 2016. On March 8, 2016, NDOT responded that vactor trucks could come up the following week if weather permitted. During a site visit on March 16, 2016, visual inspections were made and sediment depth measurements were taken in various places throughout the system. The vault that should reliably split incoming flows equally between the Contech MFS and the Jellyfish filters had 1.85 feet of accumulated sediment in it, causing the flow to preferentially enter the Jellyfish. The pipes between the splitter vault and the inflow flumes where flow is measured and samples are taken were one third to one half full of sediment. The inflow flumes were full of sediment and the continuous turbidimeters were completely buried. The Contech MFS had about 0.58 ft. of sediment accumulated in the bottom of the vault, and the Jellyfish had about 1.17 feet. Fortunately, the outflow flumes were relatively clear of sediment but dirty snowmelt was entering through the gap around the outside of the manhole cover and raining down on the flumes giving false outflow data. On March 17, 2016, Tahoe RCD was made aware that the NDOT vactor truck was out for repairs. It was decided that Tahoe RCD would refrain from taking water quality samples during events, but would continue collecting continuous flow and turbidity data even though it may not be accurate. NDOT vactored out the splitter vault and flushed the pipes between the splitter vault and the inflow flumes on April 15, 2016 (see photos below). Approximately two weeks later it was discovered that the inflow flumes and instrumentation were still covered in sediment so on May 4, 2016 the NDOT vactor truck came out and flushed the system again. A thunderstorm that occurred on May 5, 2016 was successfully sampled.

Vactor truck cleanout on 4/15/16 at SR431 (left). Note accumulated sediment along the curb. Sediment filled flume prior to cleanout (right).

Looking forward to the summer season, Tahoe RCD staff measured the depth of accumulated sediment in the Contech MFS vault at 0.75 feet on June 3, 2016. NDOT was notified immediately. On June 21 and 22, 2016 the NDOT maintenance crew was scheduled to:

- Vactor sediment from both treatment vaults
- Replace the cartridges in the Contech MFS
- Remove and clean the filters on the Jellyfish or remove and replace with the clean ones

However, Tahoe RCD staff was notified on the morning of June 21 that due to confined space issues the above described maintenance was on hold until further notice. The Tahoe RCD is hopeful that this will occur in July 2016. Event sampling for the summer season will not resume until after the system has been fully cleaned and the instrumentation checked and recalibrated. This is likely to occur a day or two after maintenance. A full account of the resolution of this issue and subsequent event sampling results will be provided in the summer seasonal progress report.
