# Country Club Heights ECP Monitoring Report

Prepared by Tahoe RCD

Prepared for El Dorado County

Elks Club Drive comprises a small portion of the total Country Club Heights Erosion Control Project (CCH) area. It was repaved in August 2018 as part of Phases 1 and 2 of the CCH project. Monitoring was conducted on Elks Club Drive as part of the larger CCH project. Stormwater samples were taken for a year prior to the repaving project, when the road was in very poor condition, and a year after the project, when the road was in excellent condition. Source apportionment analysis was conducted on the sediment in the stormwater runoff. Samples were also analyzed for sediment and nutrient concentrations. The objective of the study was to determine the total amount of sediment and nutrients delivered in stormwater runoff so the results could be used in Phase 3 of the CCH project. A secondary objective was to determine if the proportion of FSP derived from the road surface itself decreased after the road was repaved. In other words, will repaving a poor condition road result in water quality improvement? If so, could repaving roads be recognized as a water quality Best Management Practice

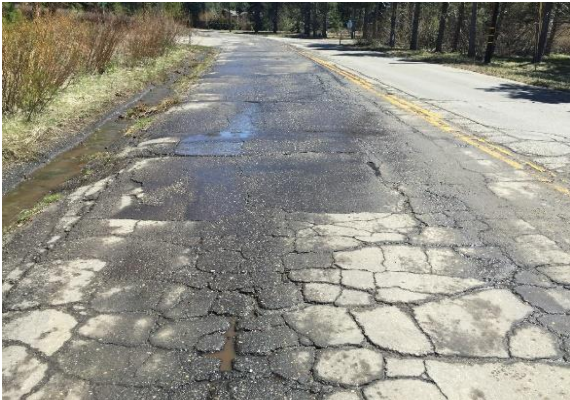
Figure 2 Elks Club Drive prior to repaving. (R Wigart)

Elks Club Drive was repaved in August 2018 as part of the CCH project, right before the start of WY19. Data collected at Elks Club in WY18 and WY19 represent pre and post project conditions respectively. Prior to repaving, Elks Club Drive was in poor condition, covered in cracks and potholes (Figure 2 - PCI: 29). In August 2018 it was repaved and is now in excellent condition (Figure 3 - PCI: 99).

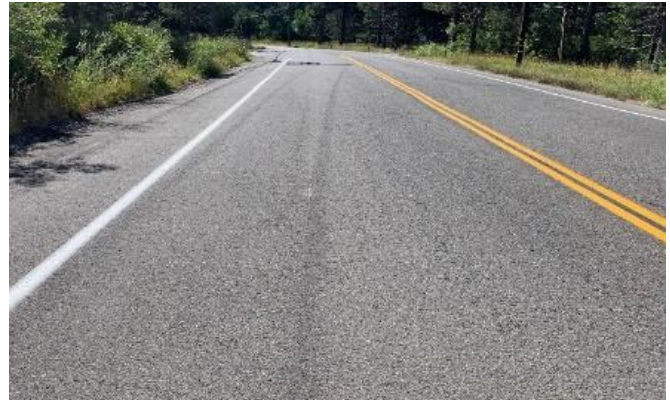
Figure 3 Elks Club Drive after repaving. (A Buxton)

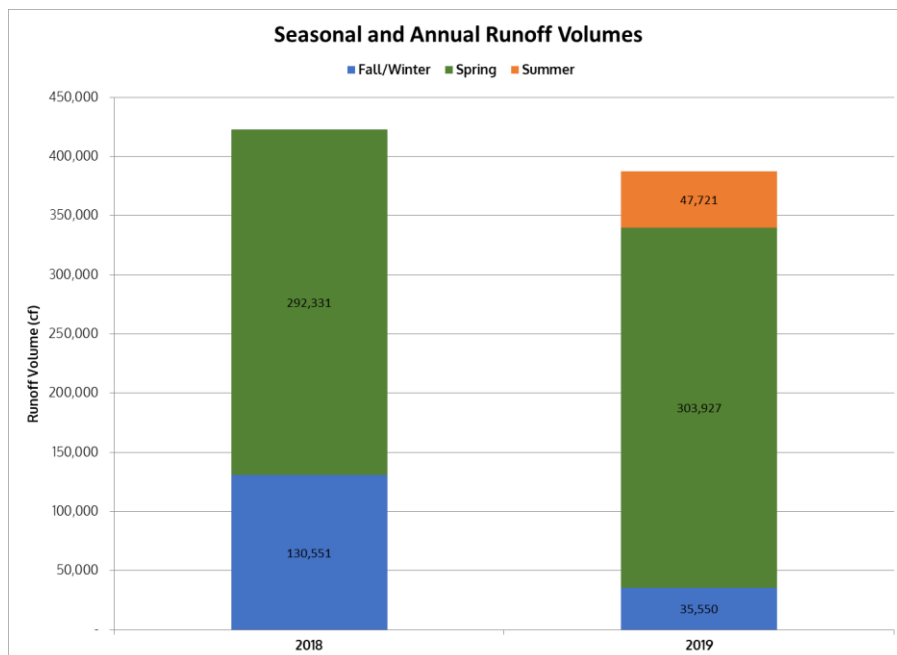
Figure 6 shows that in WY18, 422,881 cubic feet (cf) of runoff were recorded at the Elks Club monitoring station; 130,551 cf in the fall/winter, 292,331 cf in the spring, and 0 cf in the summer. In WY19, 387,197 cf of runoff were recorded at the Elks Club monitoring station; 35,550 cf in the fall/winter, 303,927 cf in the spring, and 47,721 cf in the summer. Table 4 shows this data in tabular format.

Figure 6 Runoff volumes at Elks Club monitoring station, WY18 and WY19. There was no summer runoff recorded in WY18.

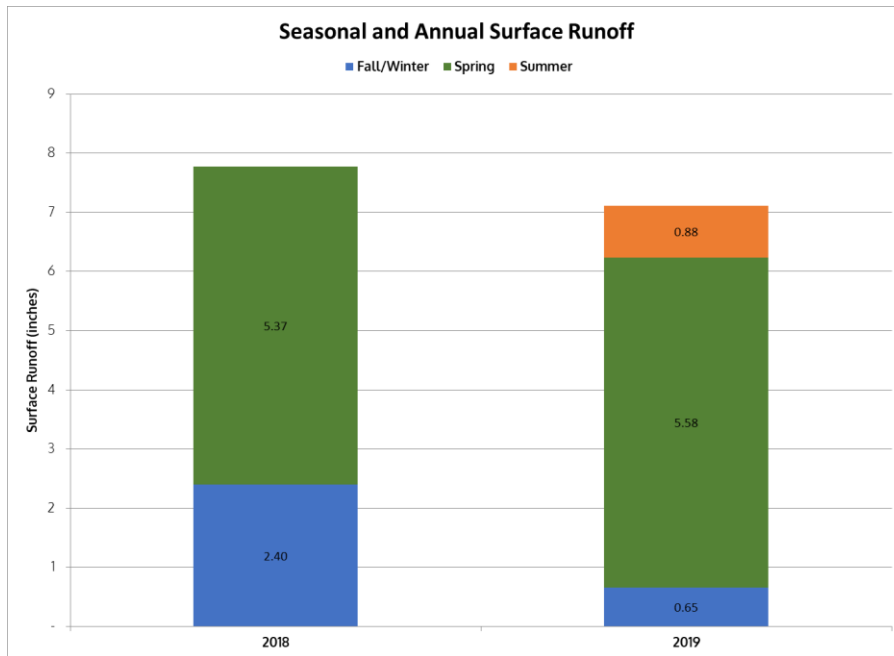
Figure 7 shows that in WY18 the surface runoff from Elks Club Drive was 8.09 inches; 2.50 inches in the fall/winter, 5.59 inches in the spring, and 0.00 inches in the summer. This corresponds to an annual runoff coefficient of 34%, and runoff coefficients for fall/winter, spring, and summer of 21%, 47%, and 0% respectively. In WY19, the surface runoff from Elks Club Drive was 7.41 inches; 0.68 in the fall/winter, 5.81 in the spring, and 0.91 in the summer. This corresponds to an annual runoff coefficient of 30%, and runoff coefficients for fall/winter, spring, and summer of 4%, 84%, and 87% respectively. Table 4 shows this data in tabular format.

Figure 7 Surface runoff at Elks Club monitoring station, WY18 and WY19. There was no summer runoff recorded during WY18.

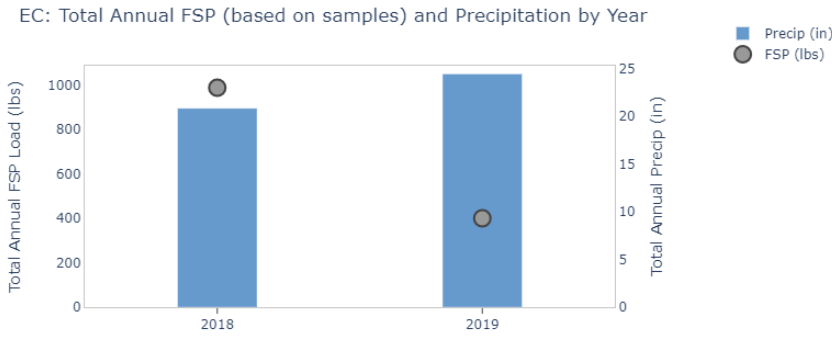
Figure 8 Total annual FSP load (based on samples) and precipitation by year for Elks Club WY18-WY19.

Figure 8 through Figure 11 show sediment and nutrient loads for Elks Club compared to total annual precipitation for WY18 and WY19. This illustrates how loading and precipitation have varied over the monitored period. Charts for FSP based on continuous turbidity are included for comparison.

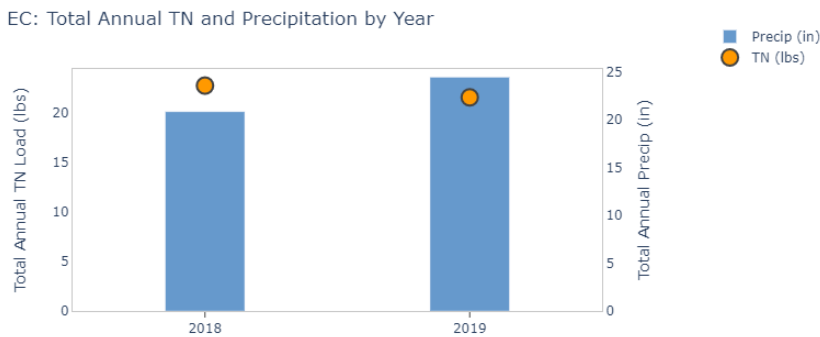
Figure 10 Total annual TN load and precipitation by year for Elks Club WY18-WY19.

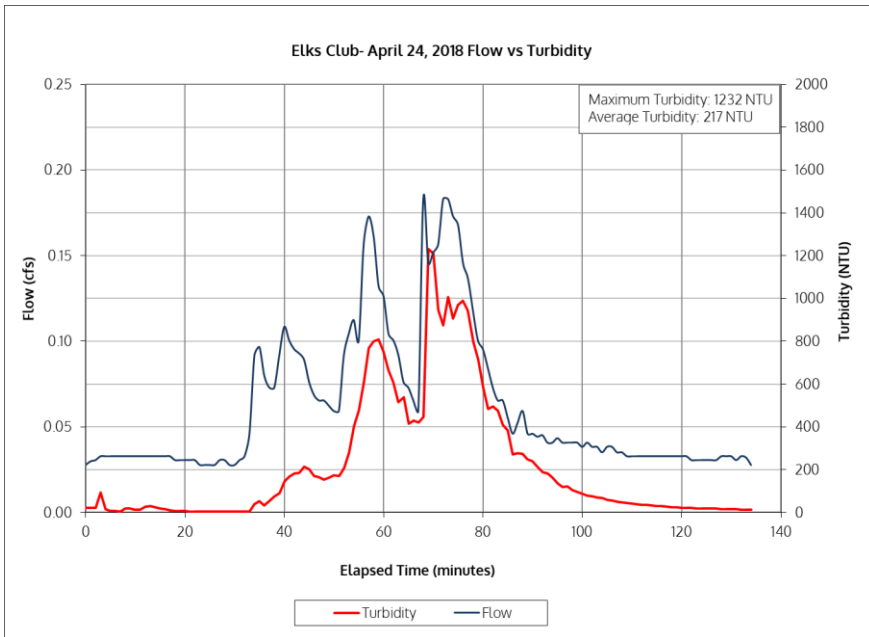
Figure 12 Continuous flow and turbidity for the pre-project condition, WY18.

Figure 12 and Figure 13 show the continuous flows and turbidities for the WY18 pre-project condition and the WY19 post project condition respectively. Pre-project condition shows a maximum turbidity of 1232 NTU and an average turbidity of 217 NTU, while the post project condition shows a maximum turbidity of 509 NTU and an average turbidity of 65 NTU, indicating a 50-60% decrease in overall sediment load. Peak flows were slightly higher in the post project condition. Figure 12 (pre-project condition) shows that turbidities were highest when the flows were highest, suggesting that there was a continuous source of sediment present. This indicates that the road surface was eroding in the pre paving condition. Figure 13 (post-project condition) shows that while turbidities did mirror flow intensity to a certain extent, at one point the turbidity leveled off and then rapidly dropped off even when flows were still high, suggesting that the source of sediment had been exhausted, and signaling a first flush condition.

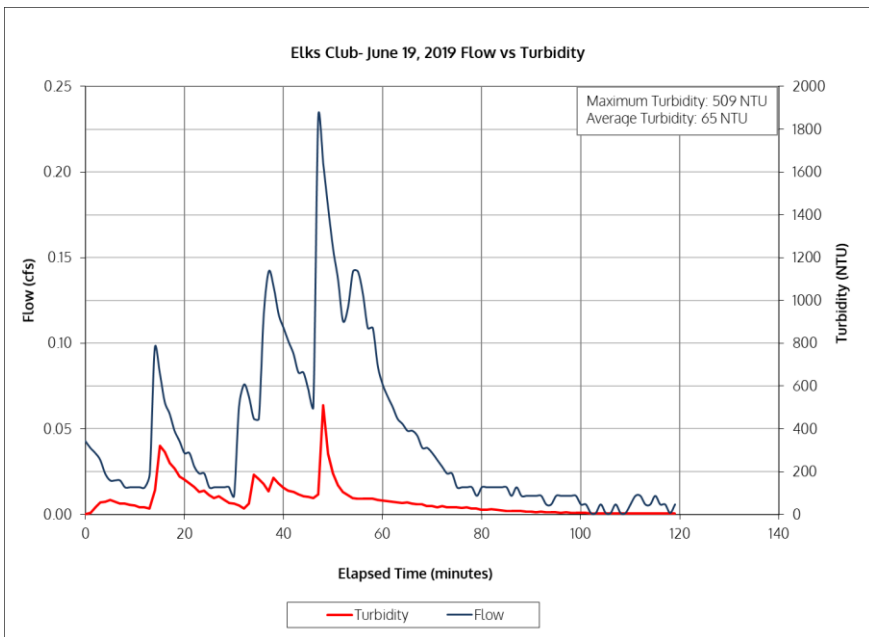
Figure 13 Continuous flow and turbidity for the post-project condition.

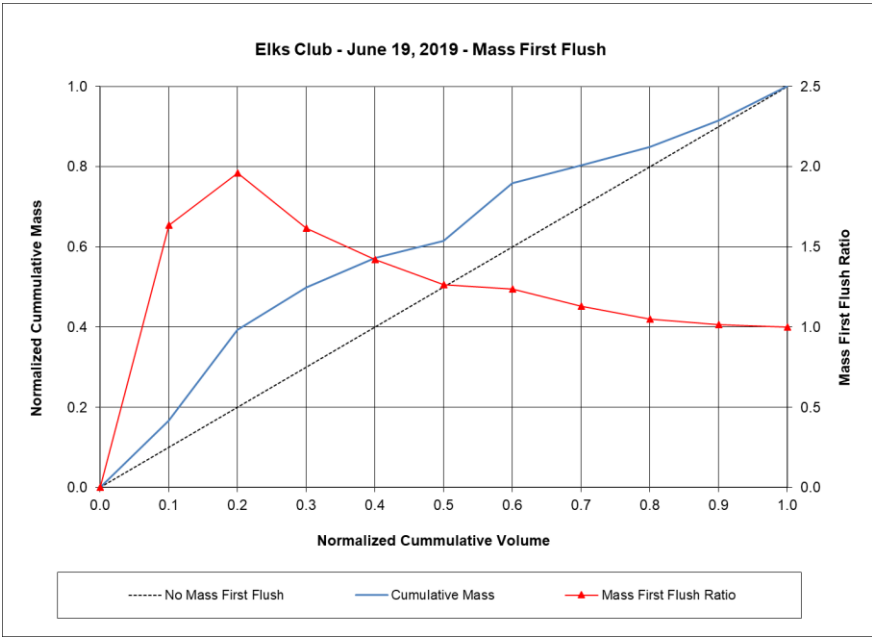
Figure 15 Mass first flush ratio for the post-project condition.

Figure 14 and Figure 15 show the mass first flush ratios for the pre-project and post-project conditions respectively. A mass first flush ratio compares the cumulative sediment mass to the cumulative volume and gives an indication of whether most of the sediment is washed off in the beginning of a flow event or not. As alluded to above, if most of the sediment is washed off with the initial flush of water, then there is no indication of continual erosion of the road surface. The dotted line in Figure 14 and Figure 15 (plotted on the primary axis) show what the graph would look like if there was no first flush (mass to volume ratio equals 1.0). In other words, when 10% of the flow has passed, 10% of the sediment mass has also passed through the monitoring site, when 20% of the flow has passed, 20% of the mass has also passed, and when 50% of the flow has passed, 50% of the mass has also passed etc. The mass first flush ratio line (plotted on the secondary axis) in Figure 14 shows that sediment was delivered throughout the runoff period, most importantly, the ratio of mass to volume was less than 1.0 at about 20% of the flow indicating that there was no first flush. The mass first flush ratio line (plotted on

the secondary axis) in Figure 15 shows that the majority of the sediment was delivered in the first 30% to 40% of the flow, in other words, the mass to volume ratio was far above 1.0 in the initial period of flow. This indicates that there was a first flush in the post project condition and suggests that the road surface was not eroding. These charts use only the continuous turbidity to estimate total sediment mass, but water quality sample analysis and source apportionment mass balance calculations confirm these results. Table 5 shows that average FSP concentration went from 220 mg/L to 12 mg/L after repaving, a 94% reduction. Table 5 also shows that FSP load went from 6.8 pounds to 0.2 pounds, a 97% reduction. Table 6 shows that the relative contribution from primary road based sources (aggregate, binder, and abrasives) all decreased after repaving while the relative contribution from primary non-road based sources (road side soil, vegetation debris) increased after repaving.
