# Seasonal Progress Report #4

## SR431 Treatment Vault Effectiveness Monitoring

**Agreement Number: P423-13-019**

**Submitted by: Tahoe Resource Conservation District**

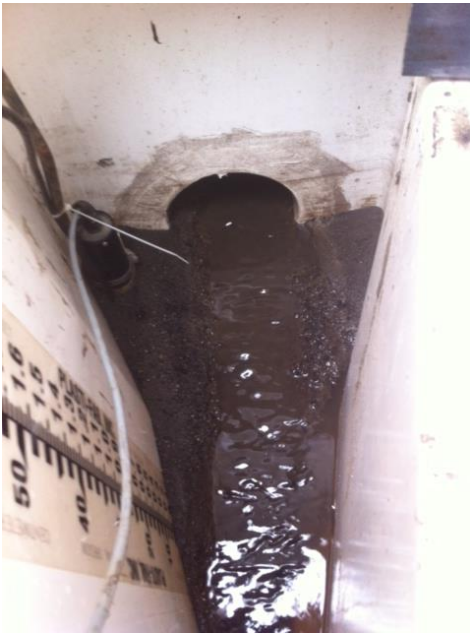
issue was resolved on March 28, 2017 when NDOT road crews removed the snow covering all four manholes. During the equipment maintenance that occurred on the same day, it was discovered that the inflow turbidimeters at both the Jellyfish and Contech were buried in sediment, and that the outflow turbidimeters were covered in a film of fine sediment. These conditions appear to have impacted the validity of February and March turbidity data.

Figure 1: Sediment covering sensors in an inflow flume.

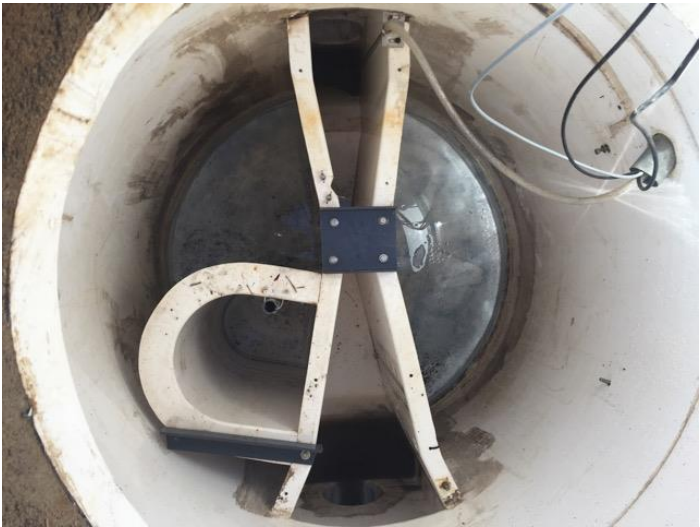
Figure 2: Clean flume after flushing and vactoring.

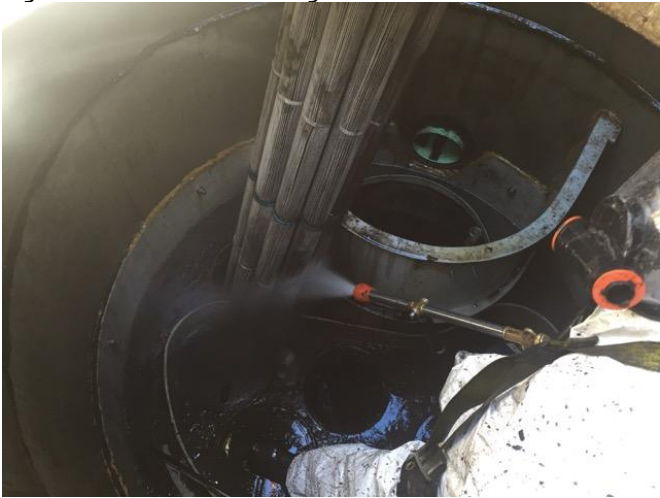
Figure 3: Pressure washing the Jellyfish filters.

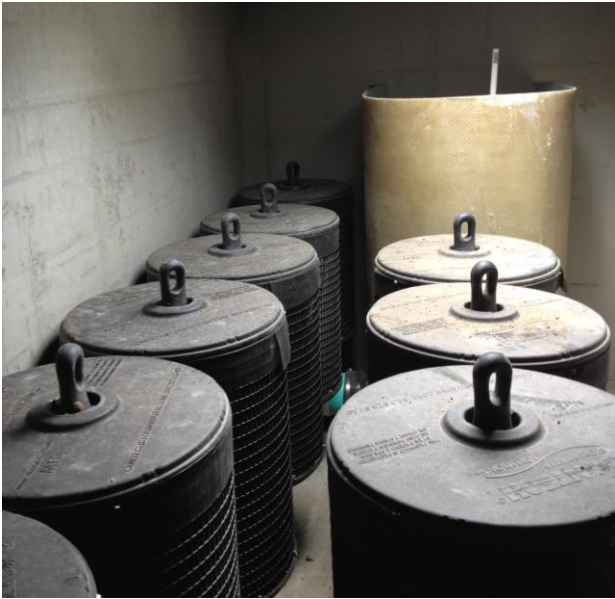
Figure 4: New Contech MFS filters.

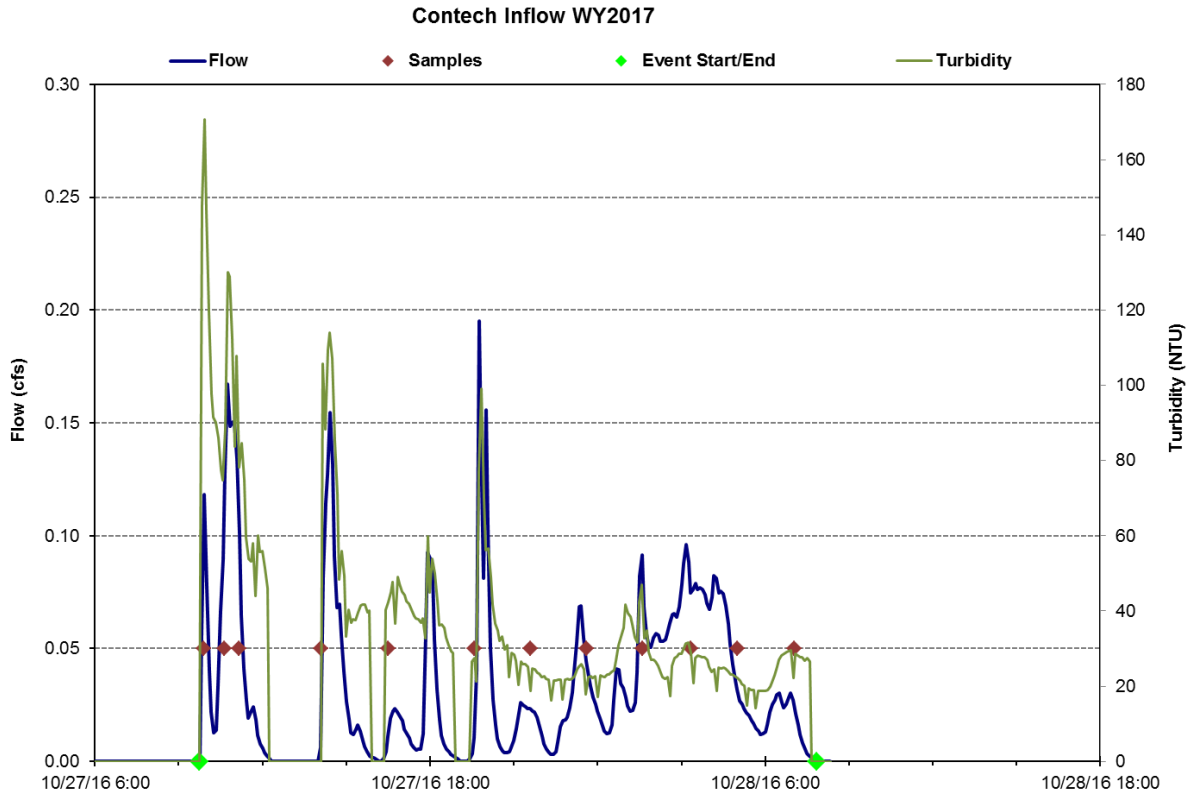
Figure 7: Hydrograph, continuous turbidity and sample distribution at the Contech Inflow for the 10/27/16 rain event.

See Figures 7-18 at the end of this report for hydrographs, continuous turbidity and sample distributions for each of the three events sampled in the fall/winter season. Hydrographs at this site generally display rapidly increasing and decreasing flows likely due to the steepness and high percentage of impervious area in the catchment. The high imperviousness causes sites to respond quickly to rapidly fluctuating precipitation intensity which causes the spikes in the flow data. In general, turbidity stays high for the duration of the event, closely mirroring flow, but may peak slightly at the beginning of the event. The consistently high turbidity is likely due to the fact that the dominant land use is primary road, which may provide a constant source of sediment during runoff events. Accumulated sediment that could not be removed due to lack of access to the monitoring equipment fouled the turbidity sensors and caused erroneous turbidity readings during the months of February and March.

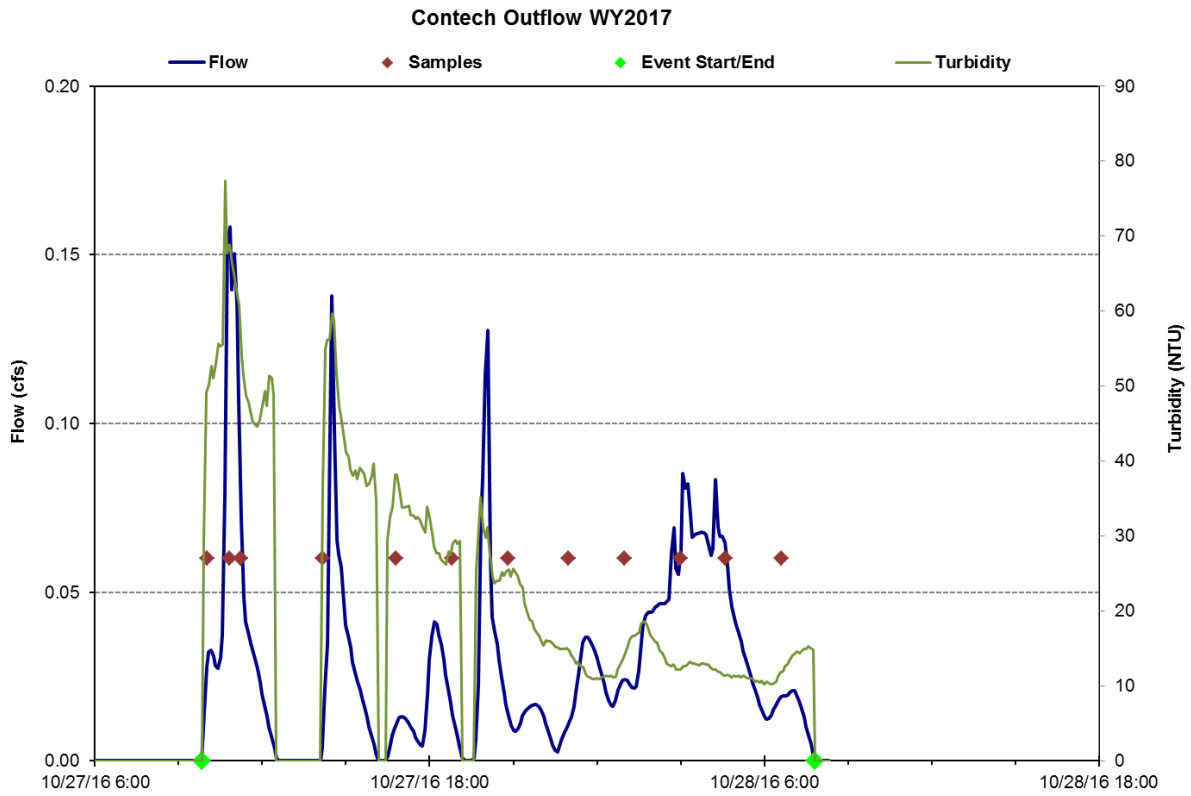
Figure 8: Hydrograph, continuous turbidity and sample distribution at the Contech Outflow for the 10/27/16 rain event.

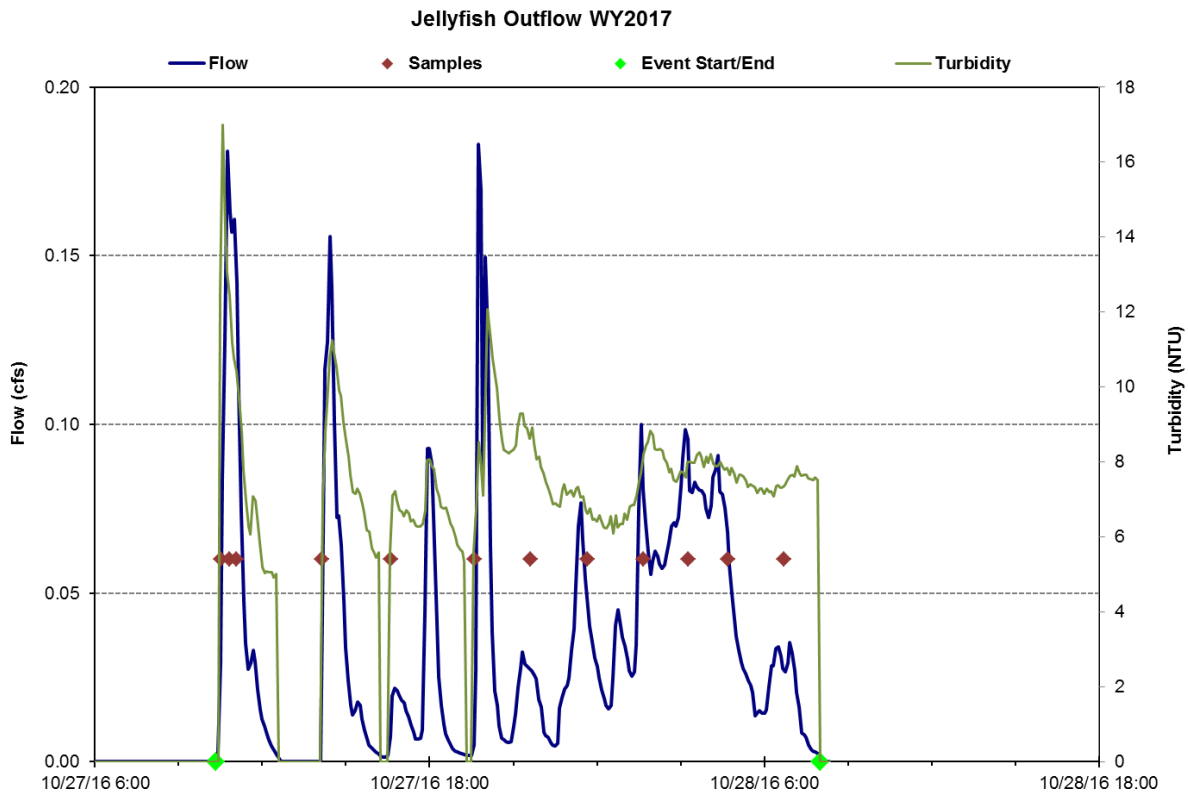
Figure 10: Hydrograph, continuous turbidity and sample distribution at the Jellyfish Outflow for the 10/27/16 rain event.

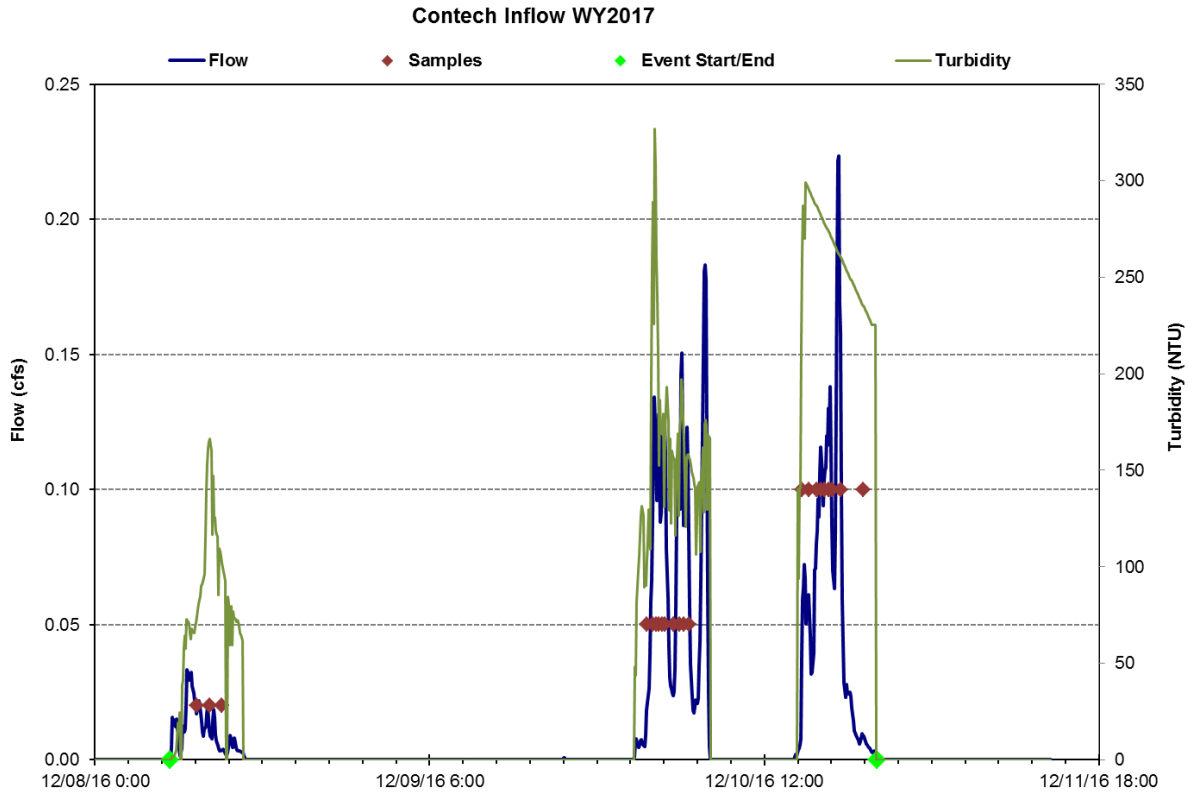
Figure 11: Hydrograph, continuous turbidity and sample distribution at the Contech Inflow for the 12/8/16 mixed snow and rain event.

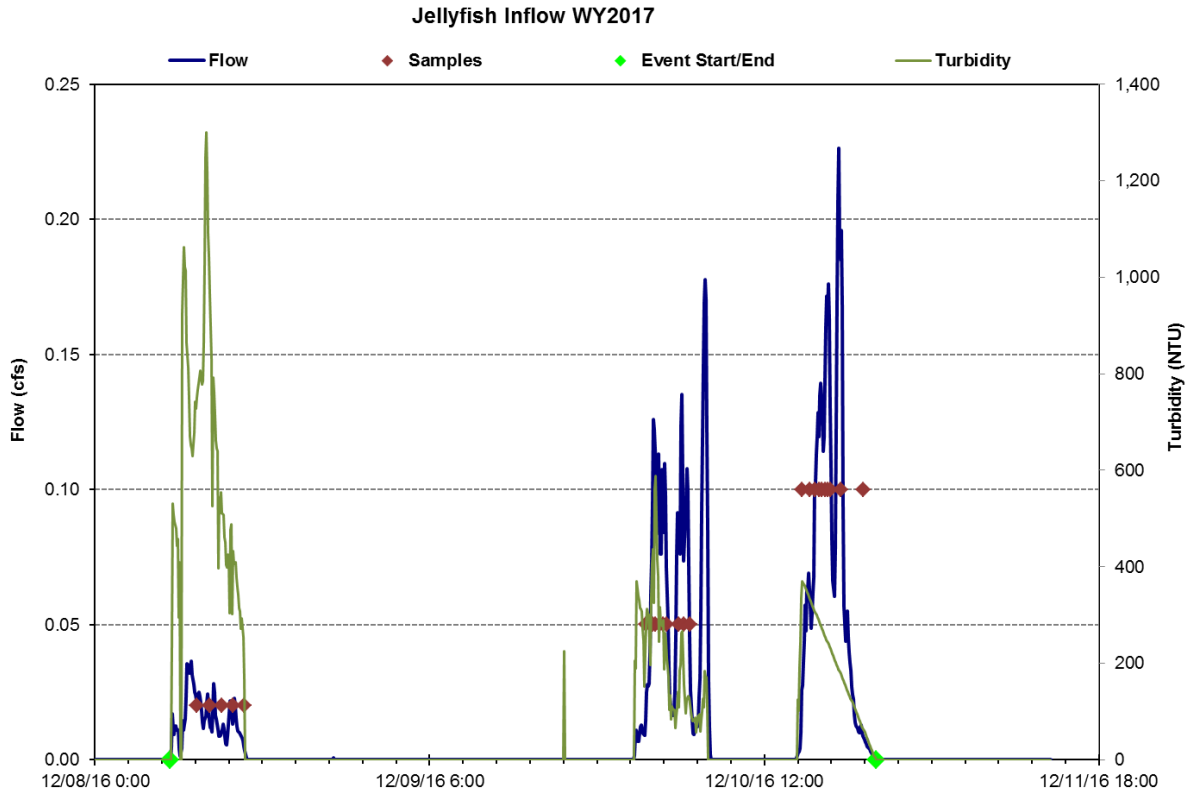
Figure 13: Hydrograph, continuous turbidity and sample distribution at the Jellyfish Inflow for the 12/8/16 mixed snow and rain event.

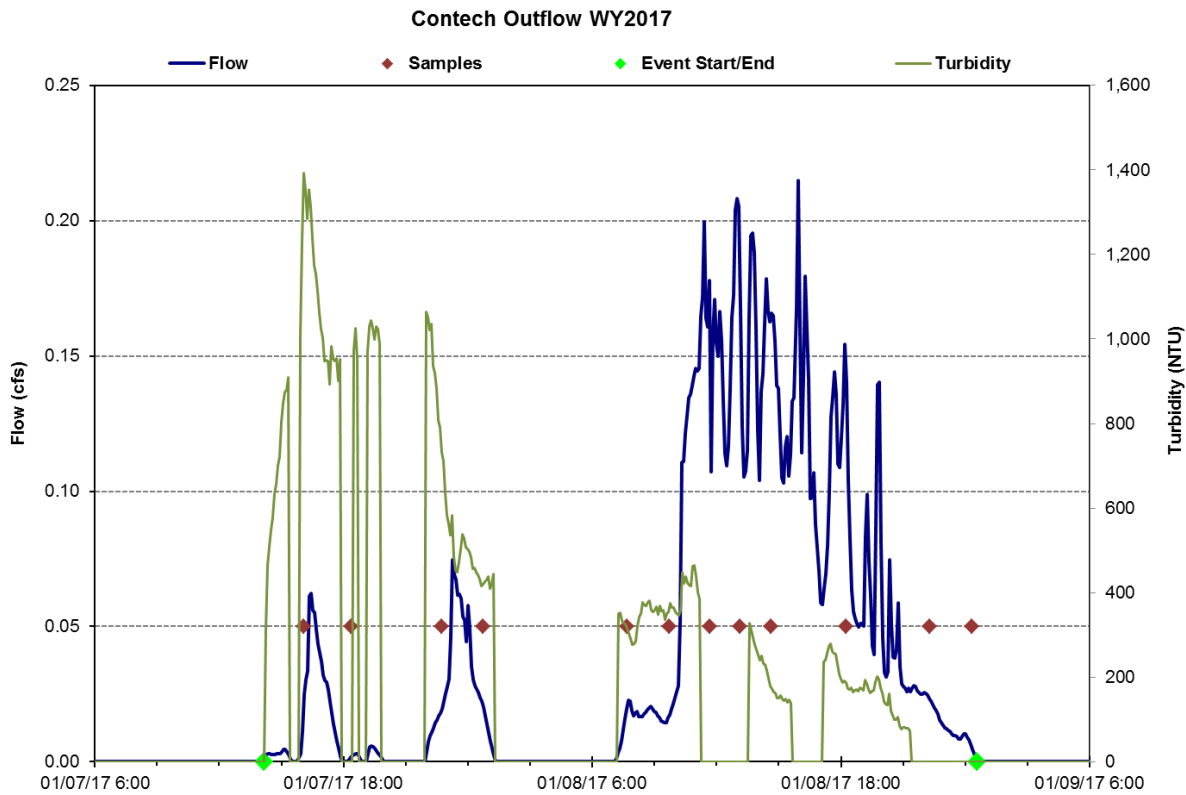
Figure 16: Hydrograph, continuous turbidity and sample distribution at the Contech Outflow for the 1/7/17 mixed rain and snow event.

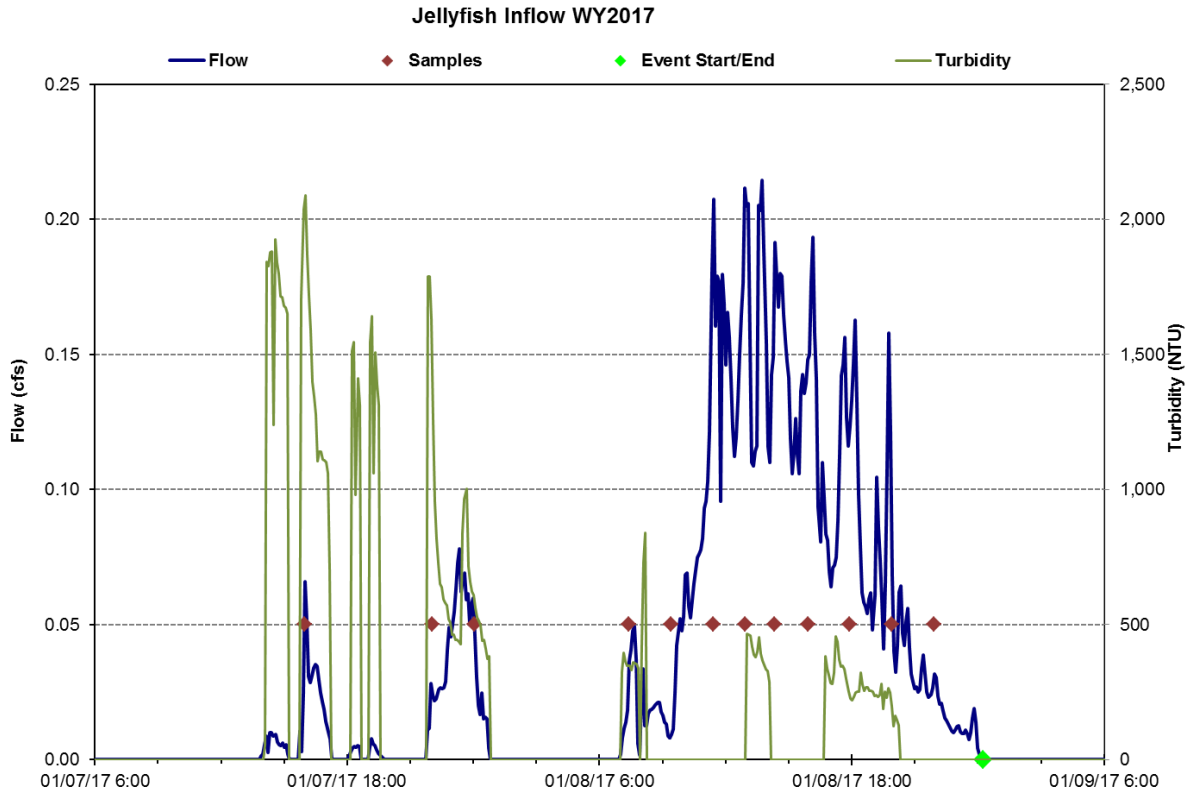
Figure 17: Hydrograph, continuous turbidity and sample distribution at the Jellyfish Inflow for the 1/7/17 mixed snow and rain event.
