Seasonal Progress Report #7

SR431 Treatment Vault Effectiveness Monitoring

Submitted by: Tahoe Resource Conservation District

Submitted to: Nevada Department of Transportation

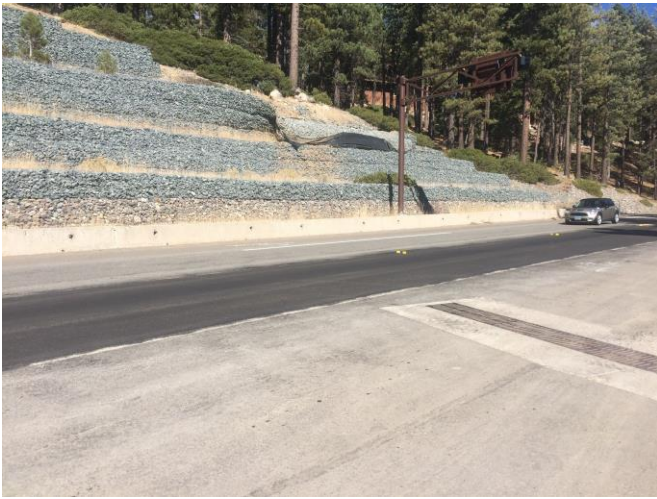
Figure 1: October 19, 2017 sediment on pullout and road.

The fall/winter season began on October 1, 2017 and ended February 28, 2018. Fall/winter of water year 2018 was exceptionally dry. Continuous flow and continuous turbidity was successfully monitored for the fall/winter the season, though only a handful of precipitation events produced runoff. There continues to be an ample source of sediment along the roadside and in the pullout above the monitoring station (Figure 1-4).

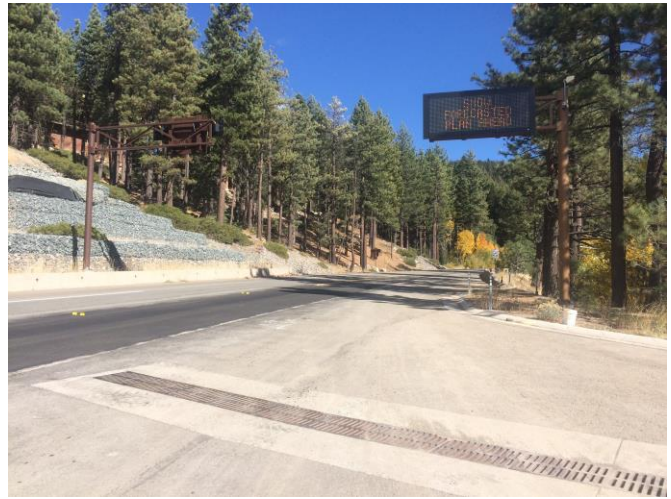
Figure 2: October 19, 2017 sediment on pullout and road.

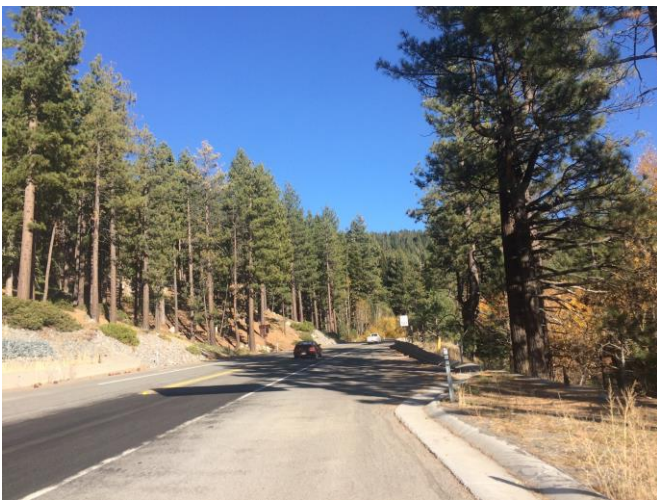
Figure 3: November 1, 2017 sediment on pullout and road.

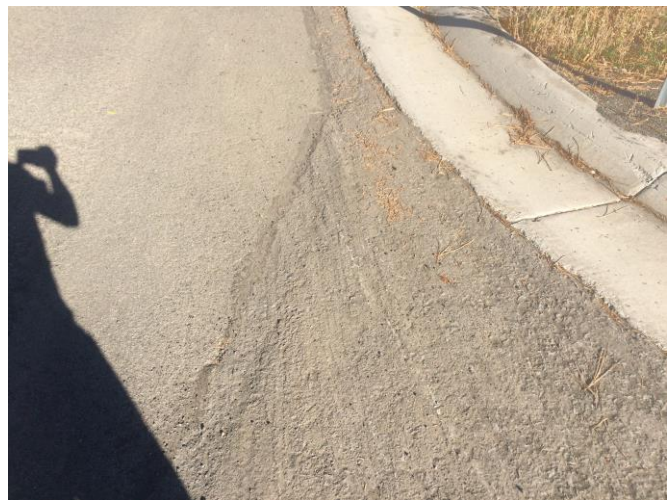
Figure 4: November 1, 2017 sediment on pullout.

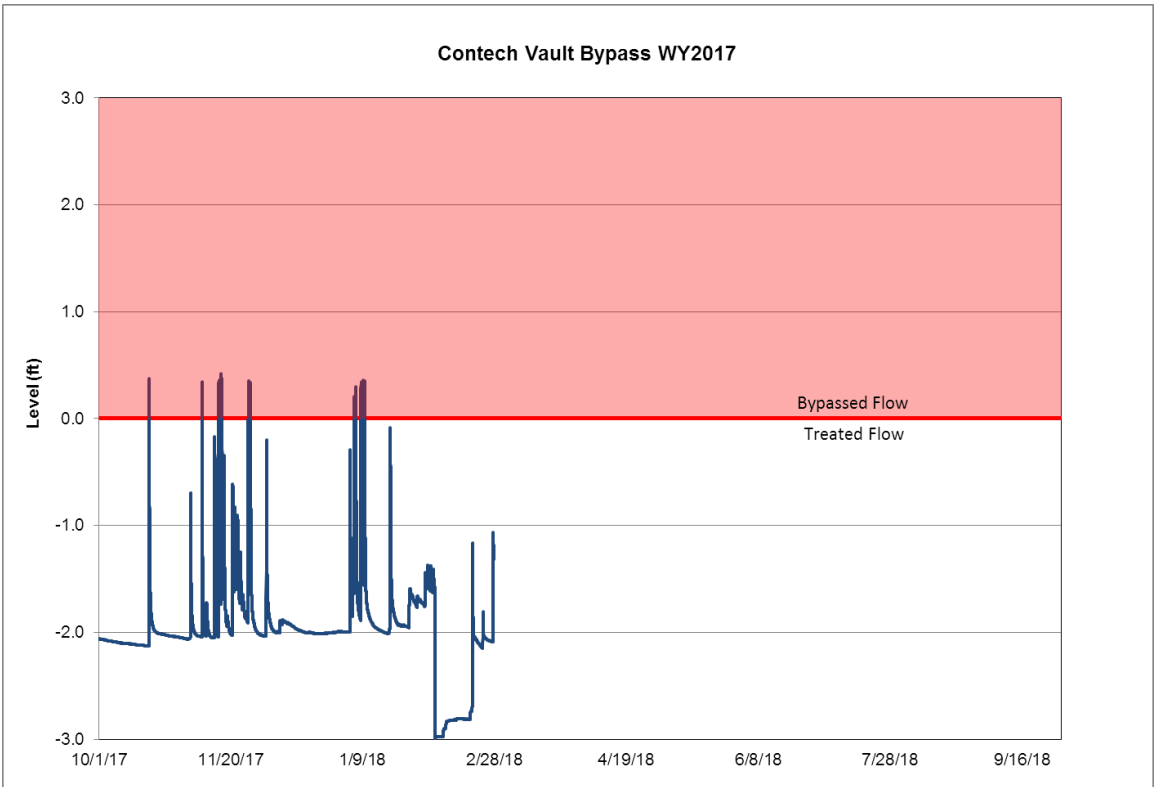
Figure 5: Bypassed flow in Contech MFS vault, fall/winter WY18

New pressure transducers were installed in June 2016 and linked to the remote access data management system currently used at the SR431 monitoring site. Data indicate that during the fall/winter of WY18 the Contech MFS cartridge filters were bypassed 6 times (October 20, 2017; November 9, 2017; November 15-16, 2017; November 26-27, 2017; January 5-6, 2017; January 8-9, 2017; see Figure 5). The Jellyfish filters bypassed once on November 16, 2017 (Figure 6).

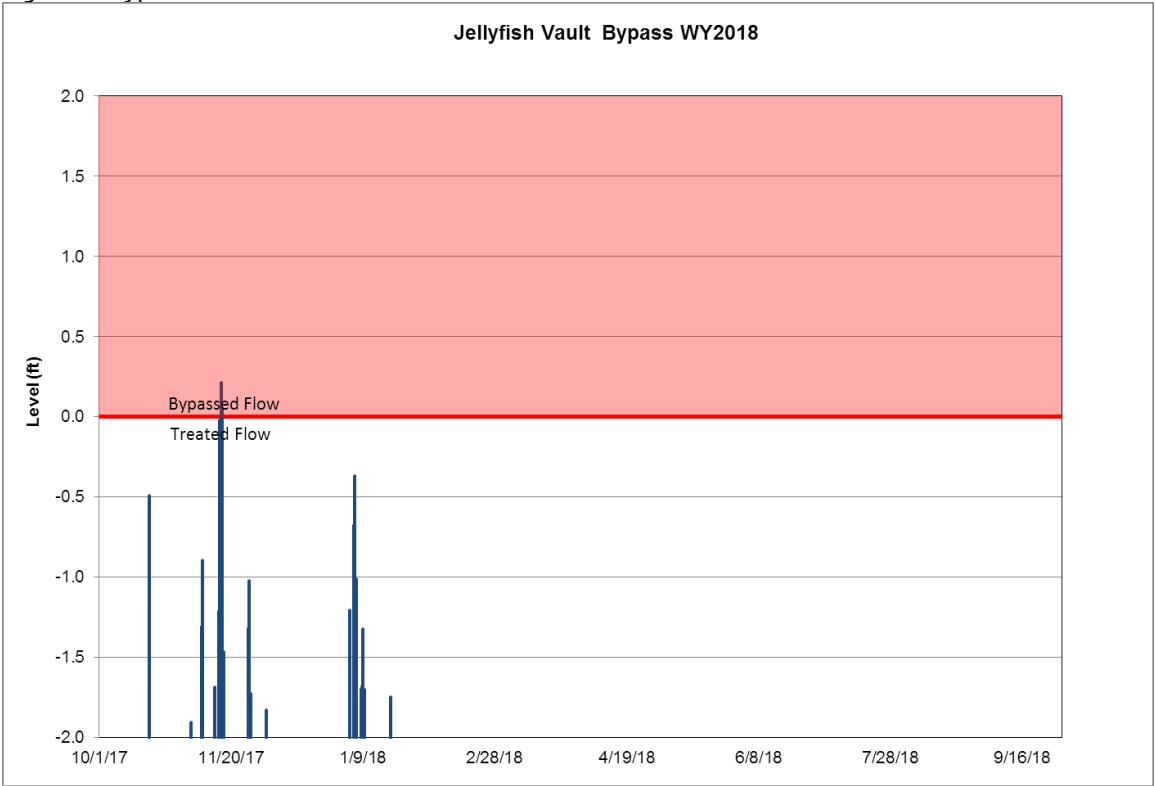
Figure 6: Bypassed flow in Jellyfish vault, fall/winter WY18.

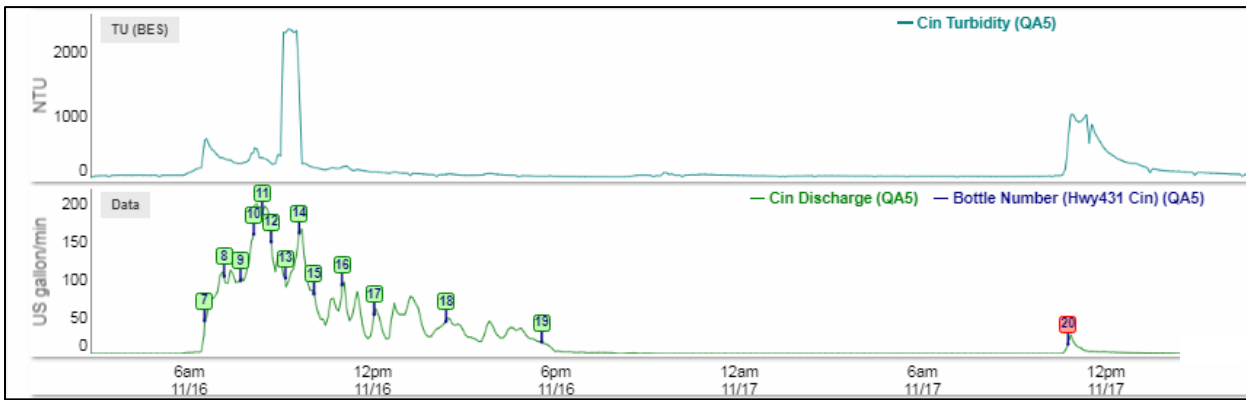
Figure 7: Hydrograph, continuous turbidity and sample distribution at the Contech MFS Inflow for the 11/16/17 rain event

See Figures 7-10 at the end of this report for hydrographs, continuous turbidity, and sample distributions for the event sampled in the fall/winter season.

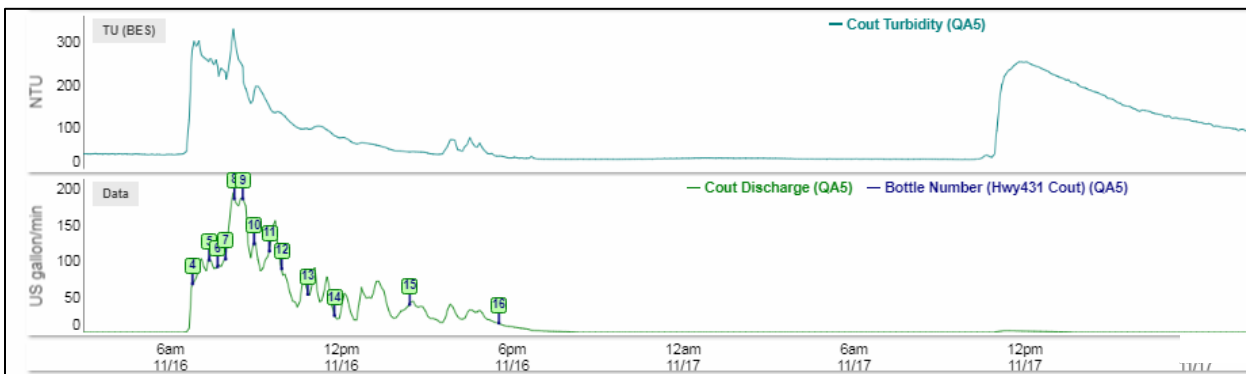
Figure 8: Hydrograph, continuous turbidity and sample distribution at the Contech MFS Outflow for the 11/16/17 rain event.

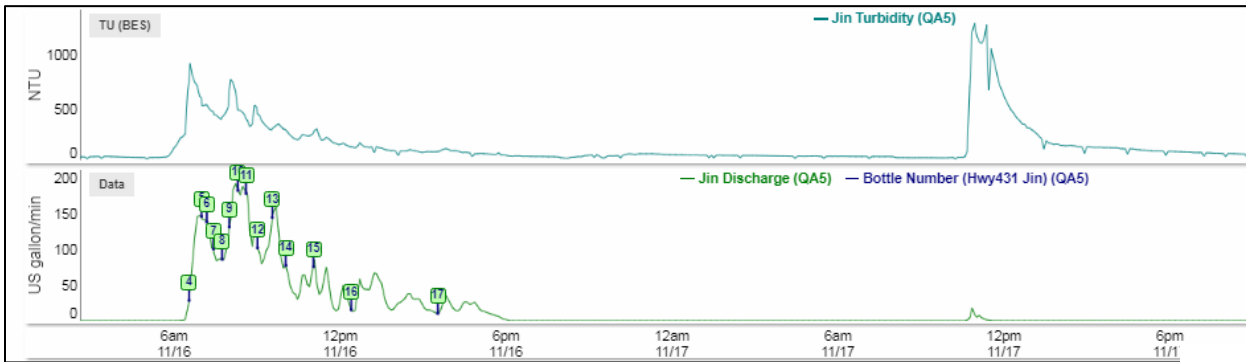
Figure 9: Hydrograph, continuous turbidity and sample distribution at the Jellyfish Inflow for the 11/16/17 rain event.

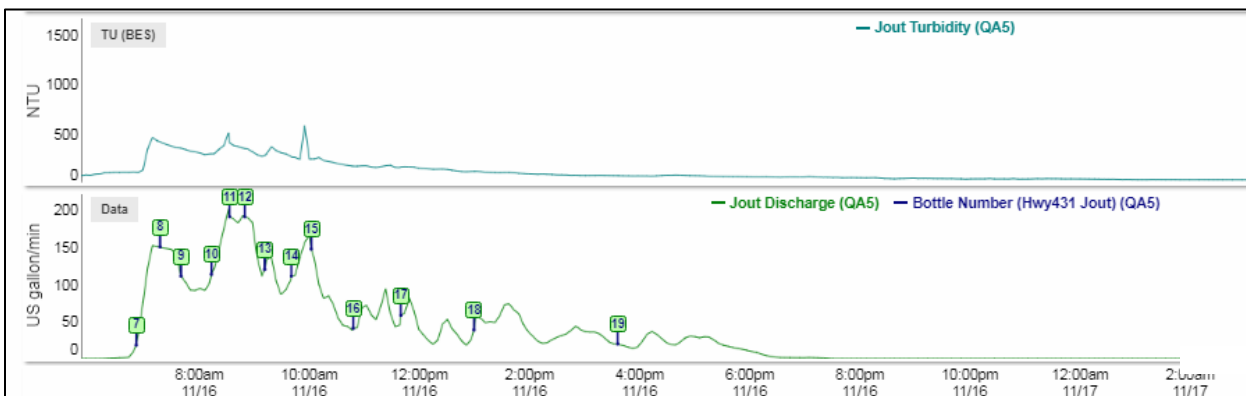
Figure 10: Hydrograph, continuous turbidity and sample distribution at the Jellyfish Outflow for the 11/16/17 rain event.
